# Manhole Inspection Summary

Manhole # S29EE2019MH

Insp Date: **12/21/06 12:03 PM**

**Location** Address: **2 MELROSE AVE**

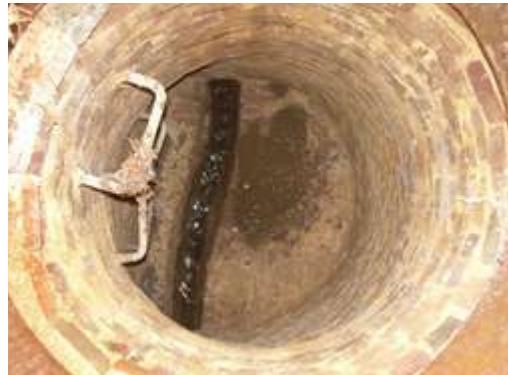
Top View

Bench debris.

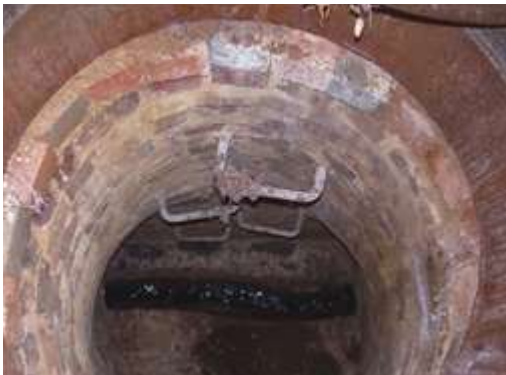
Defect

Frame leaks. Frame offset. Adjustment deterioration and infiltration. Barrel infiltration.

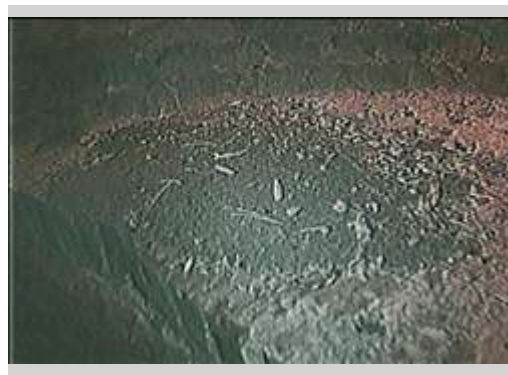
Defect

Barrel deterioration and infiltration.

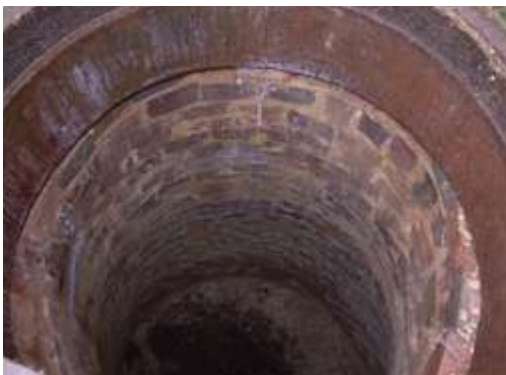
Defect

Frame leaks. Adjustment and Barrel infiltration.

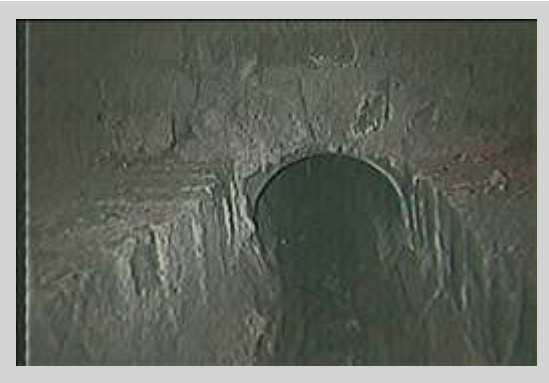
### 8 in. Circular Gravity Sewer Pipe Out @ 12 O'Clock

Infiltration: **Evidence** Pipe Seal Cond: **Unknown**

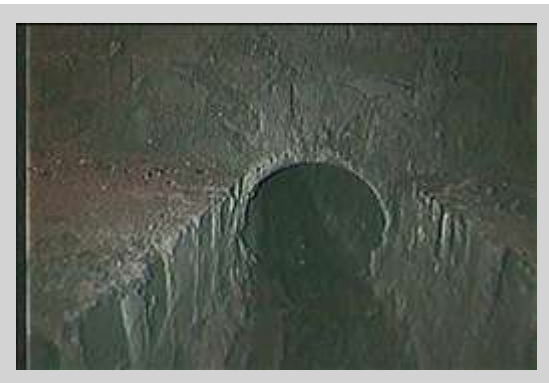
### 8 in. Circular Gravity Sewer Pipe In @ 6 O'Clock

Infiltration: **Evidence** Pipe Seal Cond: **Unknown**
